## **06/08/95 ValuJet Airlines**

## Official Accident Report Index Page

UNCONTAINED ENGINE FAILURE/FIRE VALUJET  
AIRLINES FLIGHT 597 DOUGLAS DC-9-32, N908VJ  
ATLANTA, GEORGIA JUNE 8, 1995

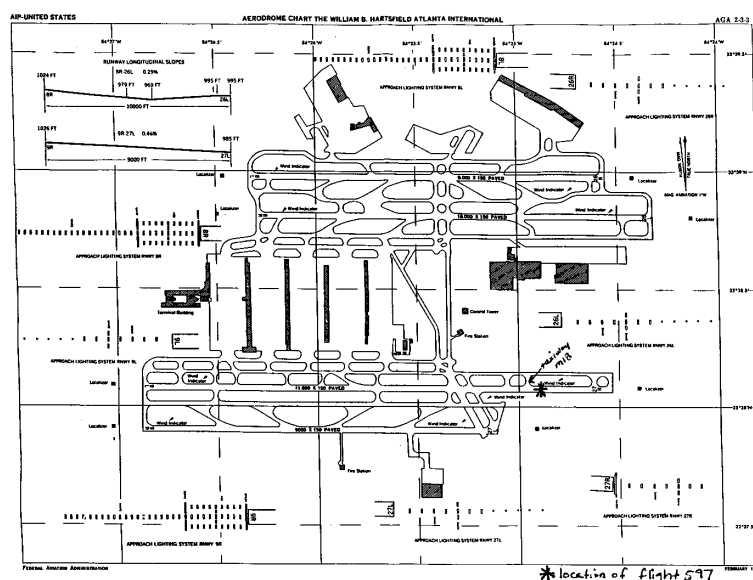
Figure 1—Location of flight 597 at Hartsfield Atlanta

The accident occurred at dusk. The airplane came to a stop about 1,500 feet down runway 27R, before taxiway M18, approximately 33° 38'04" North latitude and 84° 24'50" West longitude([see figure 1](#))

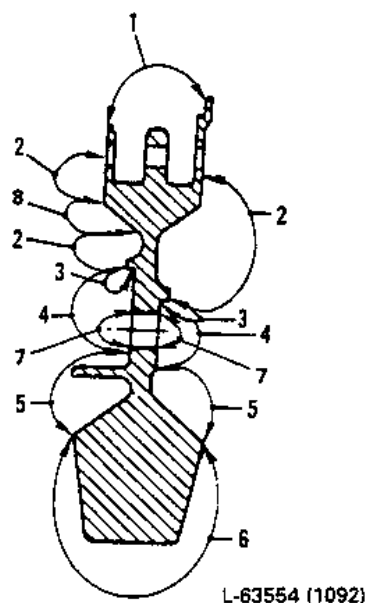
**Seventh Stage Compressor Disk**

The P&W engine manual specifies that for area 7 of the P&W figure 802 (see appendix D), which is depicted as a tierod hole, no unrepaired damage can be allowed in any hole, or within 0.125 inch of the edge of the hole on adjacent surfaces, and that damage can be repaired to a depth of 0.005 inch by blending. The instructions further indicate that damage up to 0.003 inch is acceptable in the web area of the disk without blending. The cross-section of the 7<sup>th</sup> stage disk in P&W figure 802 depicts the tierod holes, but does not have the hidden lines, [29](#) which would depict the smaller diameter SR holes behind the tierod holes, or a separate cross-section of the disk, just through the SR holes.

1. For Limits In Blade Attachment Area See Figure 803.
2. Damage Up To 0.003 Inch Acceptable Without Blending. Blend Repair To Maximum Depth of 0.005 Inch Permissible. Depth of Blends Opposite Each Other Not To Exceed 0.005 Inch Total. No Rub Indications Permitted On Rim.
3. No Unrepaired Damage Allowed. Damage To Snap Diameters Is Repairable to Depth of 0.005 Inch By Local Blending, Or 0.010 Inch By Machining And Plating To Restore Size. No Damage Allowed In Radius Between Web And Snap Diameter Within 0.125 Inch Of Tierod

4. Scattered Surface Damage Up To 0.003 Inch Deep Allowed Without Repair, Except No Damage Allowed Within 0.125 Inch of Edge Of Hole On Adjacent Surfaces. Smooth Depressions Made By Mating Parts Up To 0.005 Inch Are Acceptable Without Repair. No Paint Permitted.
5. Scattered Surface Damage Up To 0.003 Inch Deep Allowed Without Repair. Local Blend Permitted To 0.005 Inch Deep, Provided That Depth of Blends Opposite Each Other Do Not Exceed 0.005 Inch Total.
6. No Surface Damage Allowed Without Blending. Local Blend to 0.010 Inch Permitted. Permissible to Machine Bore To Maximum Depth of 0.010 Inch Radially.
7. No Unrepaired Surface Damage Allowed In Any Hole Or Within 0.125 Inch Of Edge Of Hole On Adjacent Surfaces. Repair To Depth Of 0.005 Inch By Blending.
8. Damage Up To 0.003 Inch Acceptable Without Blending. Blend Repair To Maximum Depth of 0.010 Inch Permissible.
